Prepared for:
The Corporation of the Township of North Glengarry

**CONDITION SURVEY AND OPTIONS REPORT
FRASIER ROAD BRIDGE
WSP NO.: 161-09722-00**

NOVEMBER, 2016

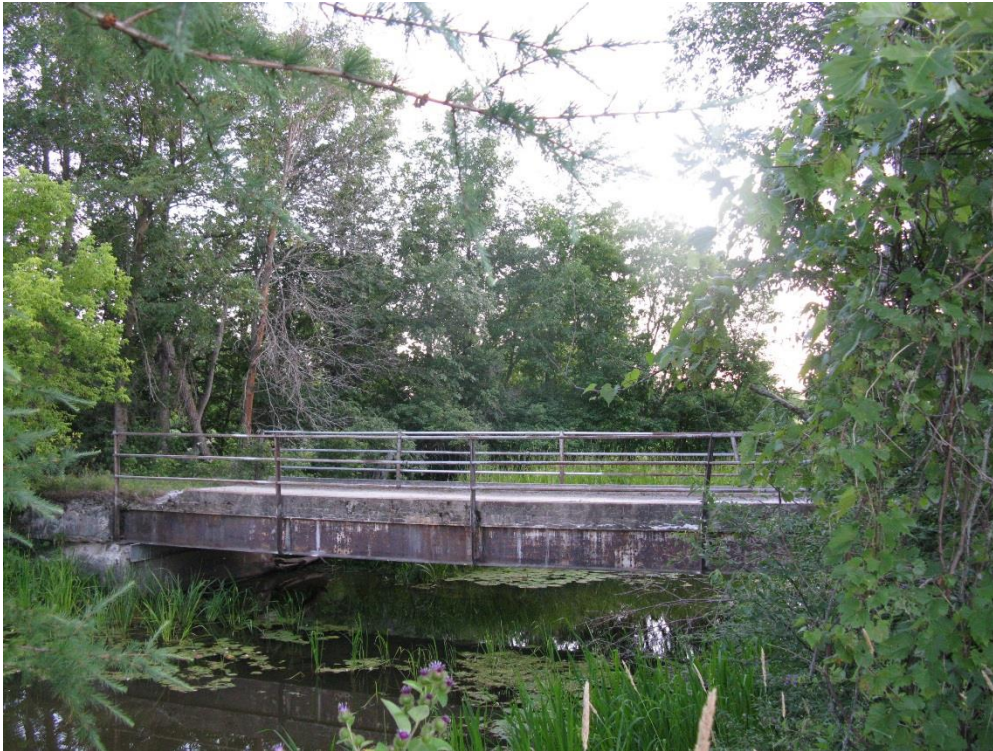
15. The wing walls of the structure are an extension of the abutments and are in extremely poor condition and disintegrating.
16. The bridge has a larger than expected permanent sag of 60mm or so.
17. The structure in a location like this and with the limited use could be equipped with curb only and would then comply with commonly accepted MTO design guidelines for Low Volume Road and could do without a railing. Therefore, the steel railing present on the structure is a bonus to users as it provides an additional safety measure.

Picture 1. West Elevation. Note noticeable sag of the bridge. The corner at the left now supported by channel bolted to abutment.

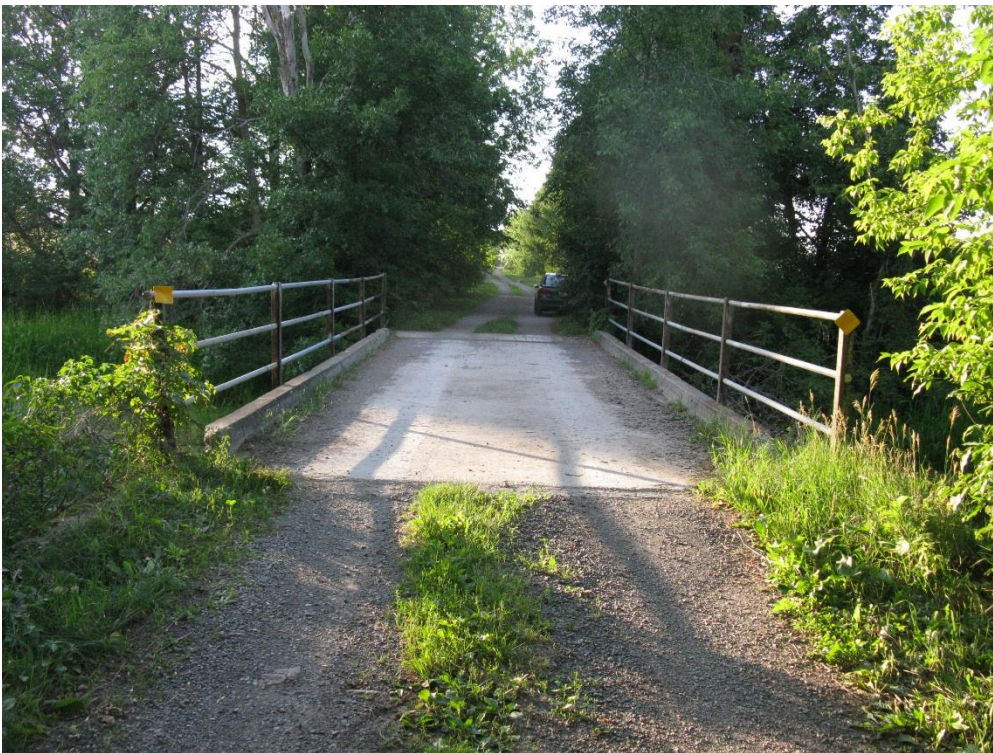
Picture 2. Overall view of top of the deck looking north.

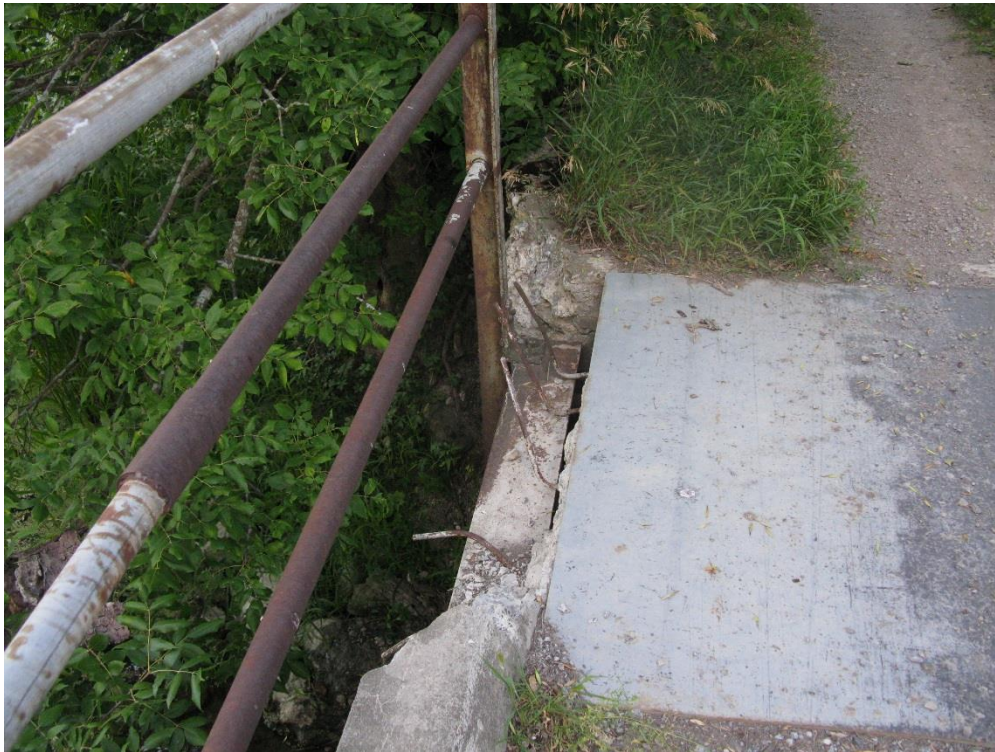
5. A portion of the concrete deck was lost due to disintegration at the northwest corner, possibly due to the movement at that location when the support under the girder was lost (see observation #9). A 20mm thick steel roadway plate, full width of roadway, over the deteriorated area has been installed. The installation of the steel plate is an adequate interim solution.

6. The concrete curb has been lost to disintegration at all 4 corners of the structure.
7. The deck is supported by five closely spaced stringers and two main beams along the edge; therefore the concrete deck is not subject to excessive stresses. As the deck has only bottom reinforcing, the top of the deck is still in relatively fair condition with the exception of the northwest corner. There are obvious signs of deterioration and aging on the top and underside of the 70 years old deck.

Picture 3. Curb and deck broken off at northwest corner and steel plate was installed.

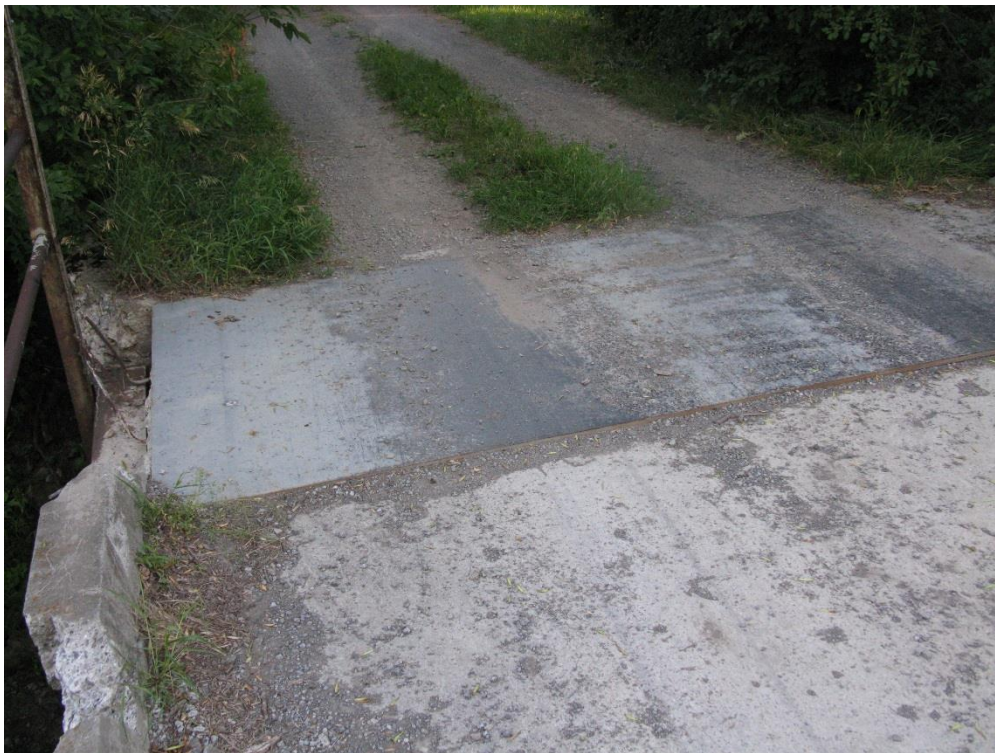
Picture 4. Heavy steel plate across the deck at the north end.

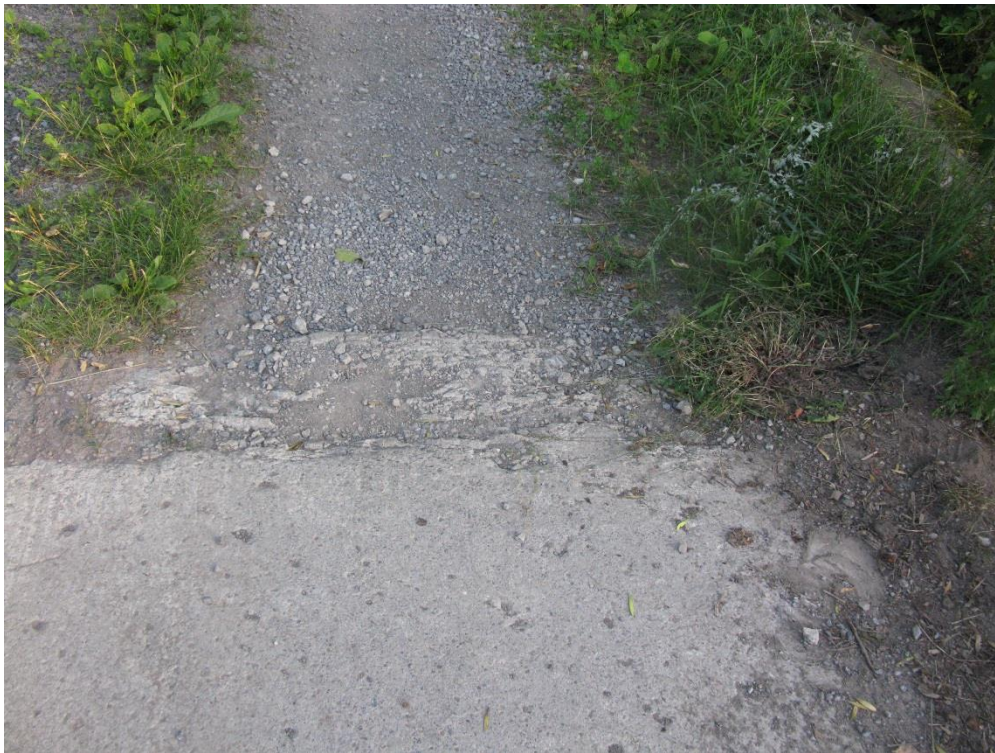
14. The structure was built with concrete ballast walls. Remnants of these are still visible, however the concrete is completely broken up and disintegrated. The ballast walls are being held together by remnants of its original integrity, some reinforcing, friction of the fill and support offered by the concrete upstands.

Picture 5. Completely disintegrating ballast walls in top of the road.

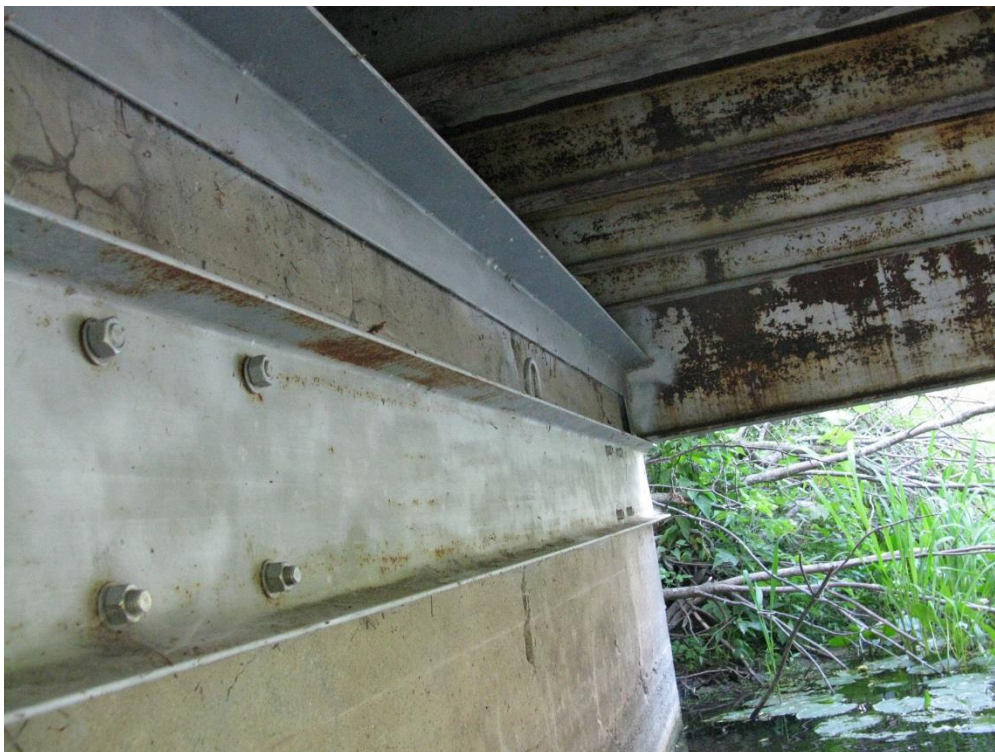
12. A steel channel was bolted to each of the abutments and this channel supports the main girders. While the work was executed well, the channel size is relatively small and while sufficient to support the dead weight of the deck and steel, it is inadequate to support larger vehicles.

Picture 6. Steel channels were bolted to abutments to support the girders.

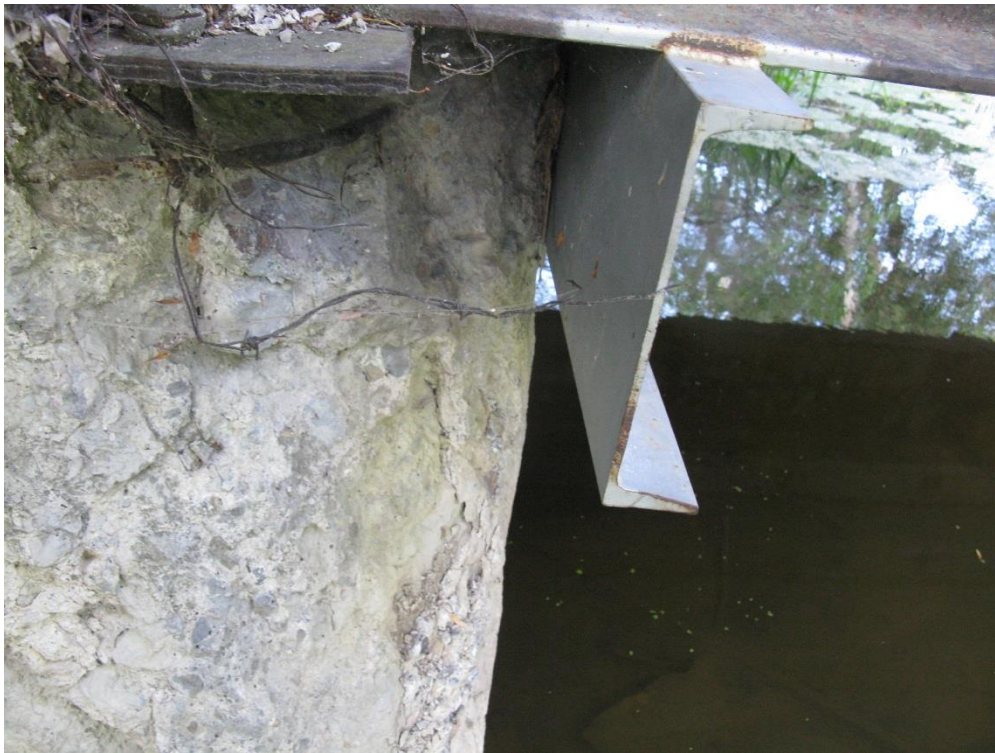
9. Concrete in the bearing seat under the north end of the west beam has disintegrated and at one point in time that end of the beam was unsupported which means the corner of the bridge was, to some degree, hanging unsupported until a repair strategy was implemented.

10. Concrete in the bearing seat under the north end of the east beam is in good condition.
11. Concrete under the south end of both beams has started to disintegrate however there is still 50% of support remaining.

Picture 7. The northwest corner where bearing seat was lost and the end of girder is supported by channel. The other three corners have still residual bearing capacity.

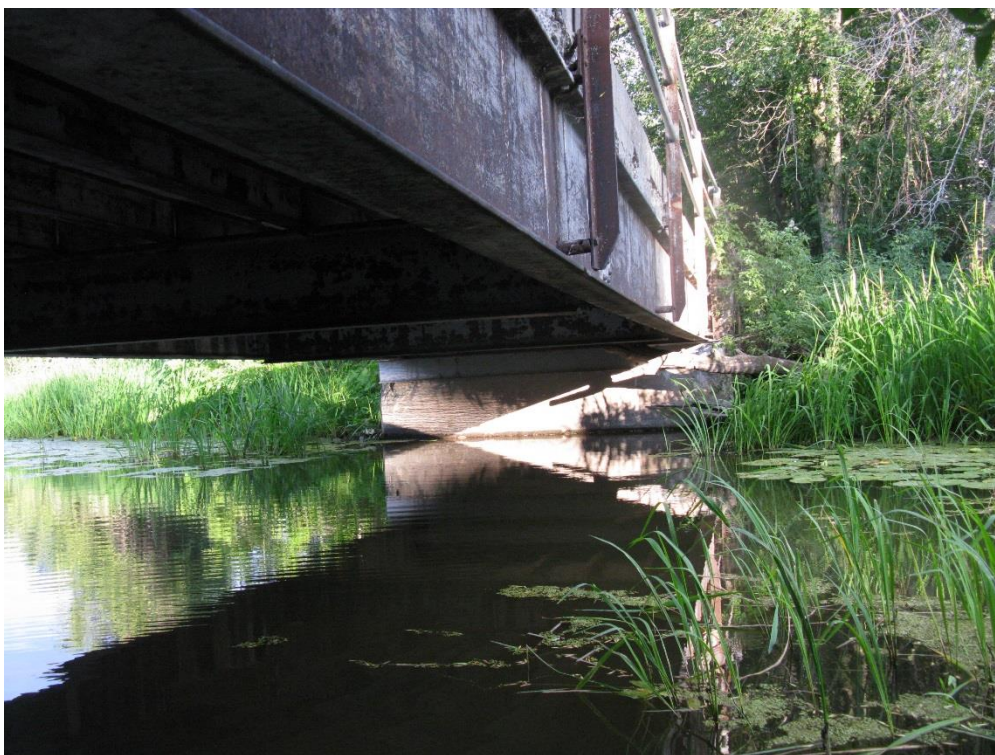
Picture 8. Overall view of underside. Note sag in girder.

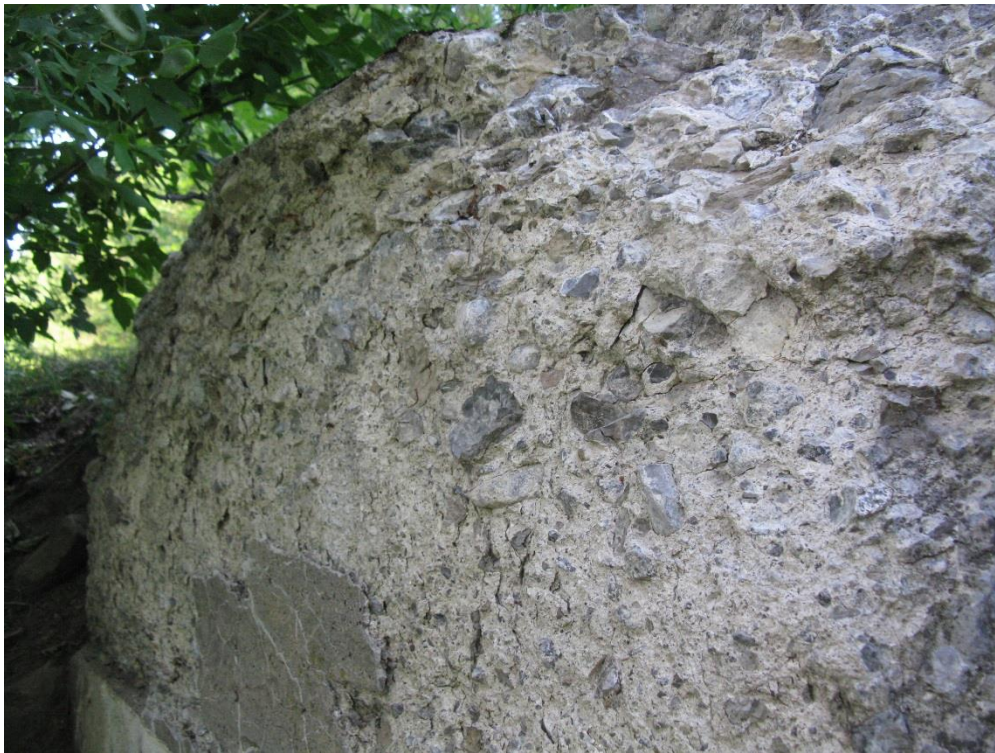
Picture 9. Disintegration of northwest wingwall.

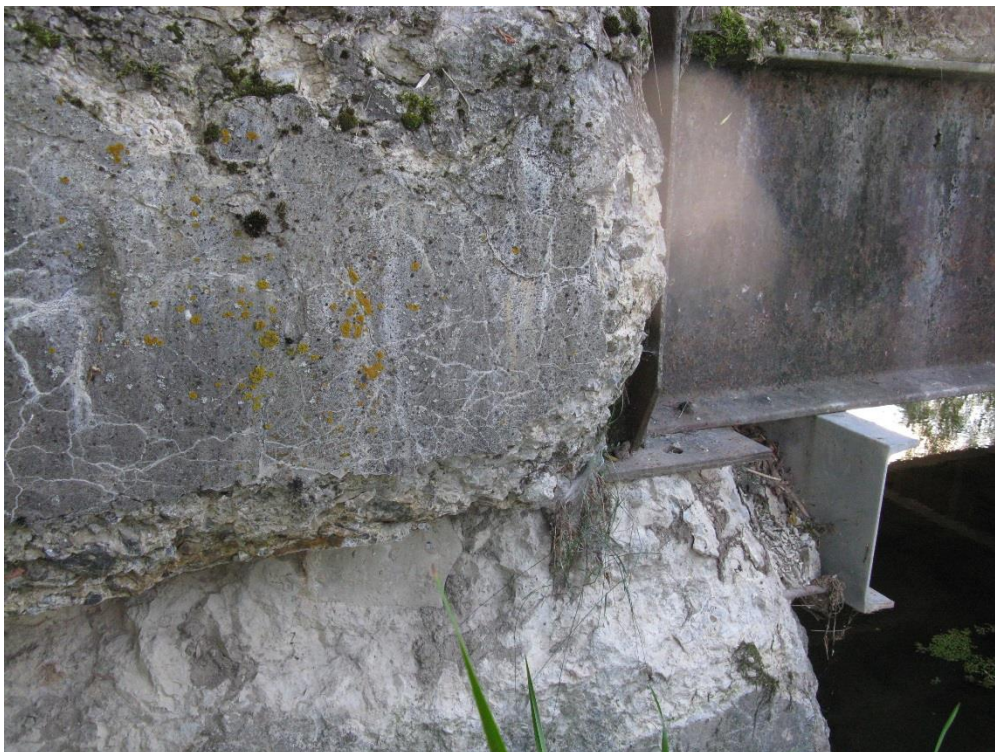
Picture 10. Disintegration of southeast wingwall.
