Prepared for:
The Corporation of the Township of North Glengarry

**CONDITION SURVEY AND OPTIONS REPORT
FRASIER ROAD BRIDGE
WSP NO.: 161-09722-00**

NOVEMBER, 2016

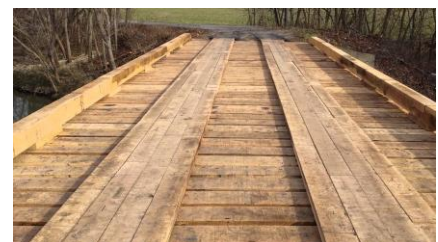
Option 3: Carry out extensive repairs and maintain the structure for 30 years.

The work would consist of removing the concrete deck and wingwalls and ballast wall, while the stem of the abutments and concrete pedestals supporting the stringers will remain. The bearing seats will be repaired as per Option 2 above and the top section of the abutments will be reconstructed. The steel superstructure will remain and a new timber deck with a timber curb will be installed. With this option the overall width of the structure can be slightly increased to allow the use of wider farm vehicles if necessary, or they will overhang over the curb. The life span will be limited by longevity of the deck and future corrosion of structural steel which will likely limit the life span of the structure to 30 years.

The structure will likely require load posting in the range of 20 tonnes.

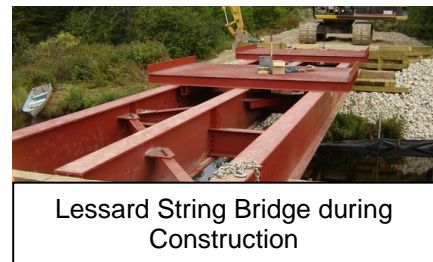
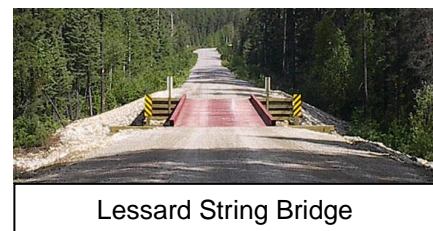
The most suitable candidate for this location will be an 72' Lessard String Bridge. The bridge has a very similar width to the existing and is manufactured with a steel plate curb. According to the MTO Low Volume Roads policy, only a curb is required on the bridge given the low AADT and the low speed. The narrow bridge would not impede passage of wider farm vehicles as the steel curb should not provide an obstruction. The bridge would not have a railing however due to liability an appropriate signage advising users of lack of railing will be required especially considering that the existing bridge has a railing. A railing would be required on the bridge if pedestrian use is prevalent.

A serious issue was raised previously in the Geotechnical Report advising not to use spread footings due to potential settlement due to layer of the clay. We are not in agreement with the notion of not using spread footings for the Lessard Bridge as these bridges are actually intended for locations where settlement may occur. The designer would need to simply calculate how much settlement will occur in the future and simply build the bridge higher.

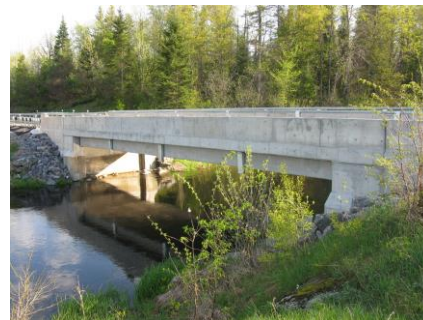
This option is described in detail in the Environmental Assessment and dealt with in the Geotechnical Report. A simple concrete bridge on piled foundations (or caissons) was suggested and we agree that this is a type of structure that would be suitable for this location.

The EA assessment suggest budget of \$525,000 in 2007 while the 2015 OSIM suggested budget of \$800,000. These two numbers are similar when the 2007 costs are indexed to 2016. We believe that a traditional bridge on caissons or piles in this location will carry price tag approaching the \$800,000 or possibly more in total construction and engineering costs subject to timing of construction (water levels) and choice of railing, wearing surface.

While we are not privy to the opinion of the Township on the matter of available budget, we do not condone expenditure of capital costs of this magnitude for a structure in this location, especially that other options are available.
